Figure 1 The cost of California's fire history  
 (data provided by California Department of Forestry and Fire Protection)

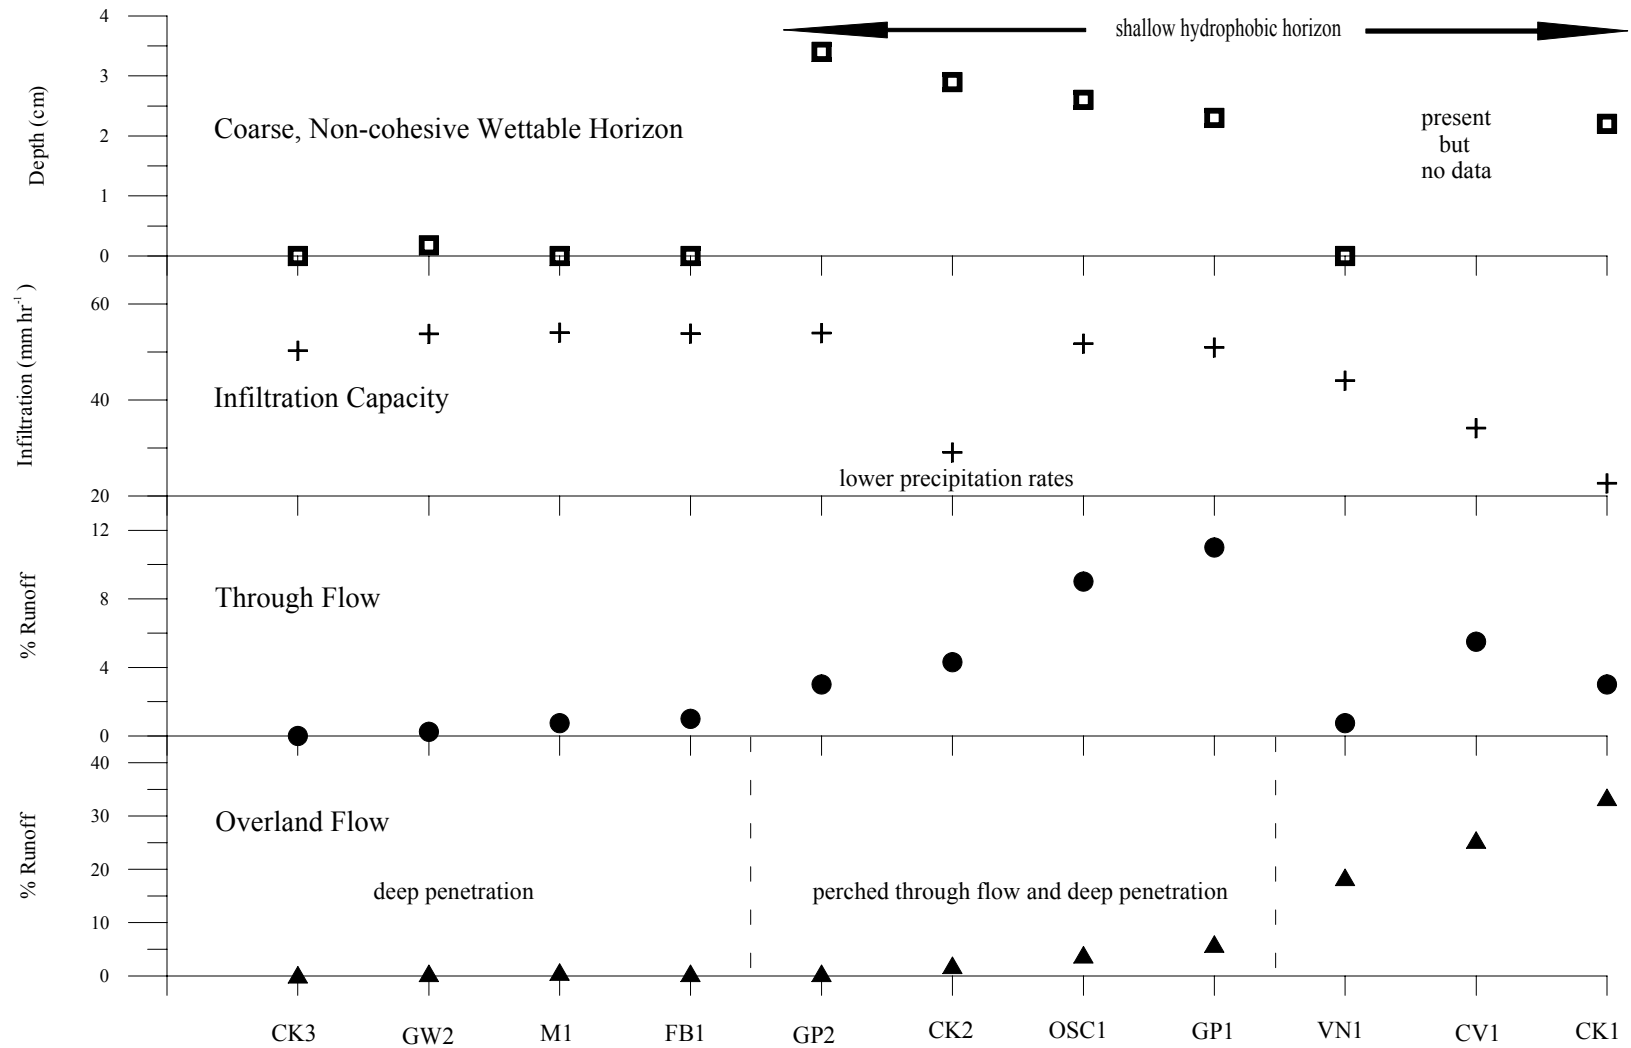
Figure 5 Runoff, Throughflow, Infiltration Capacity, and the Thickness of the Wettable Horizons for Sprinkler Experiment Plots

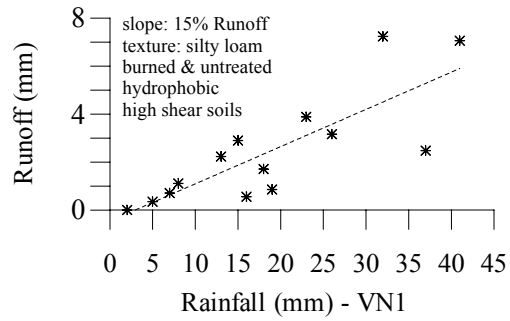
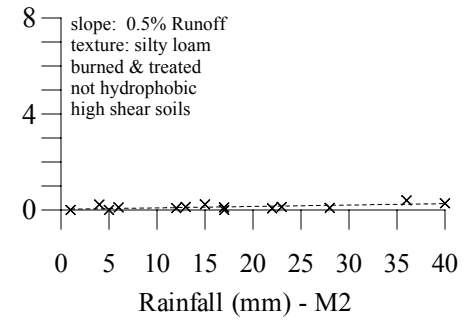
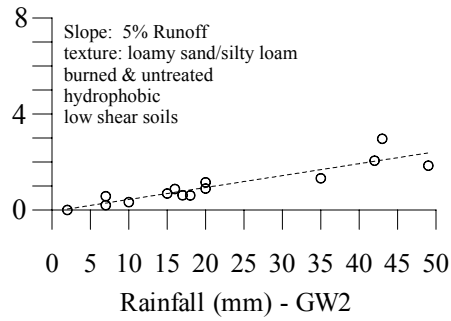
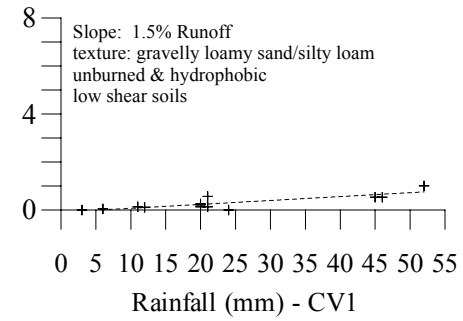
Figure 6 Runoff - Rainfall Relationships for Winter Storms in the Oakland Hills (for soils with different shear strengths and hydrophobic character)

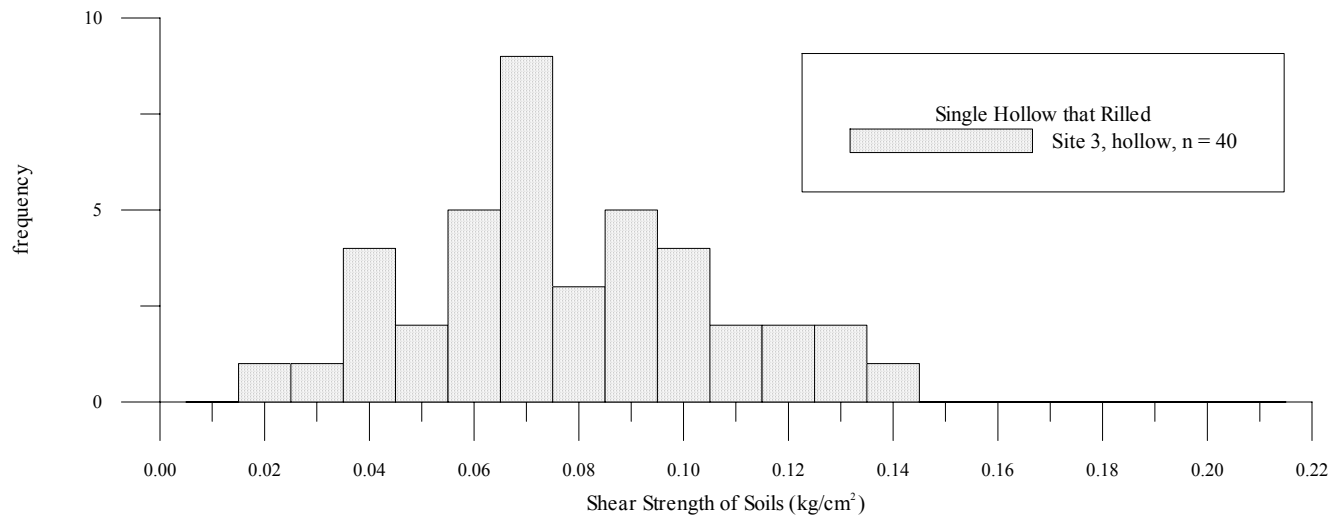
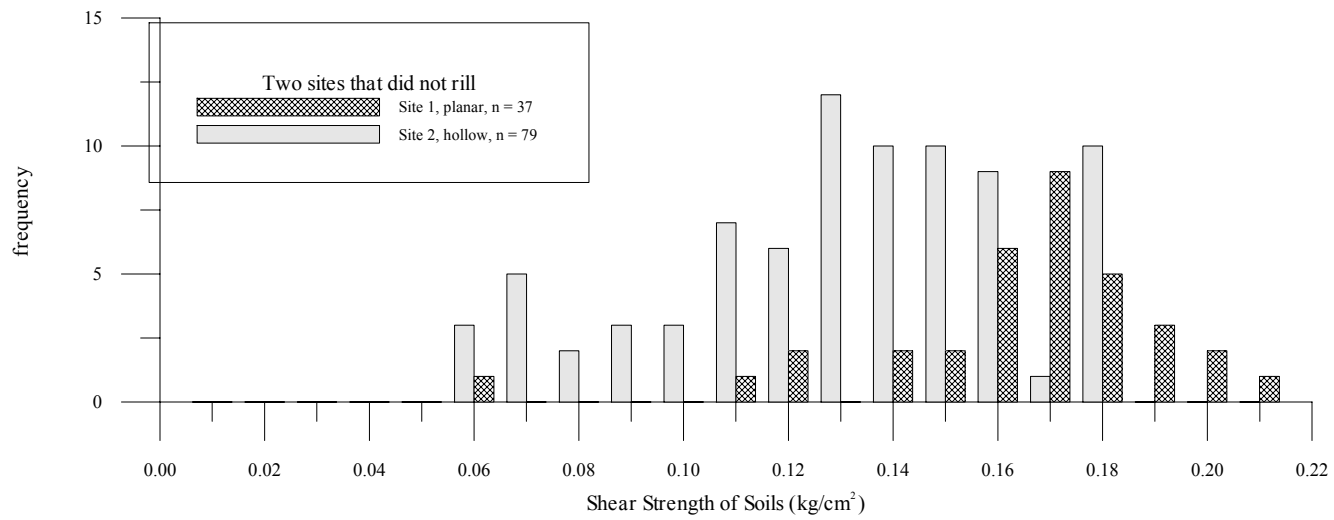
Figure 7b Shear strength of soils at 3 sites within the Calabasas Fire area, Los Angeles County

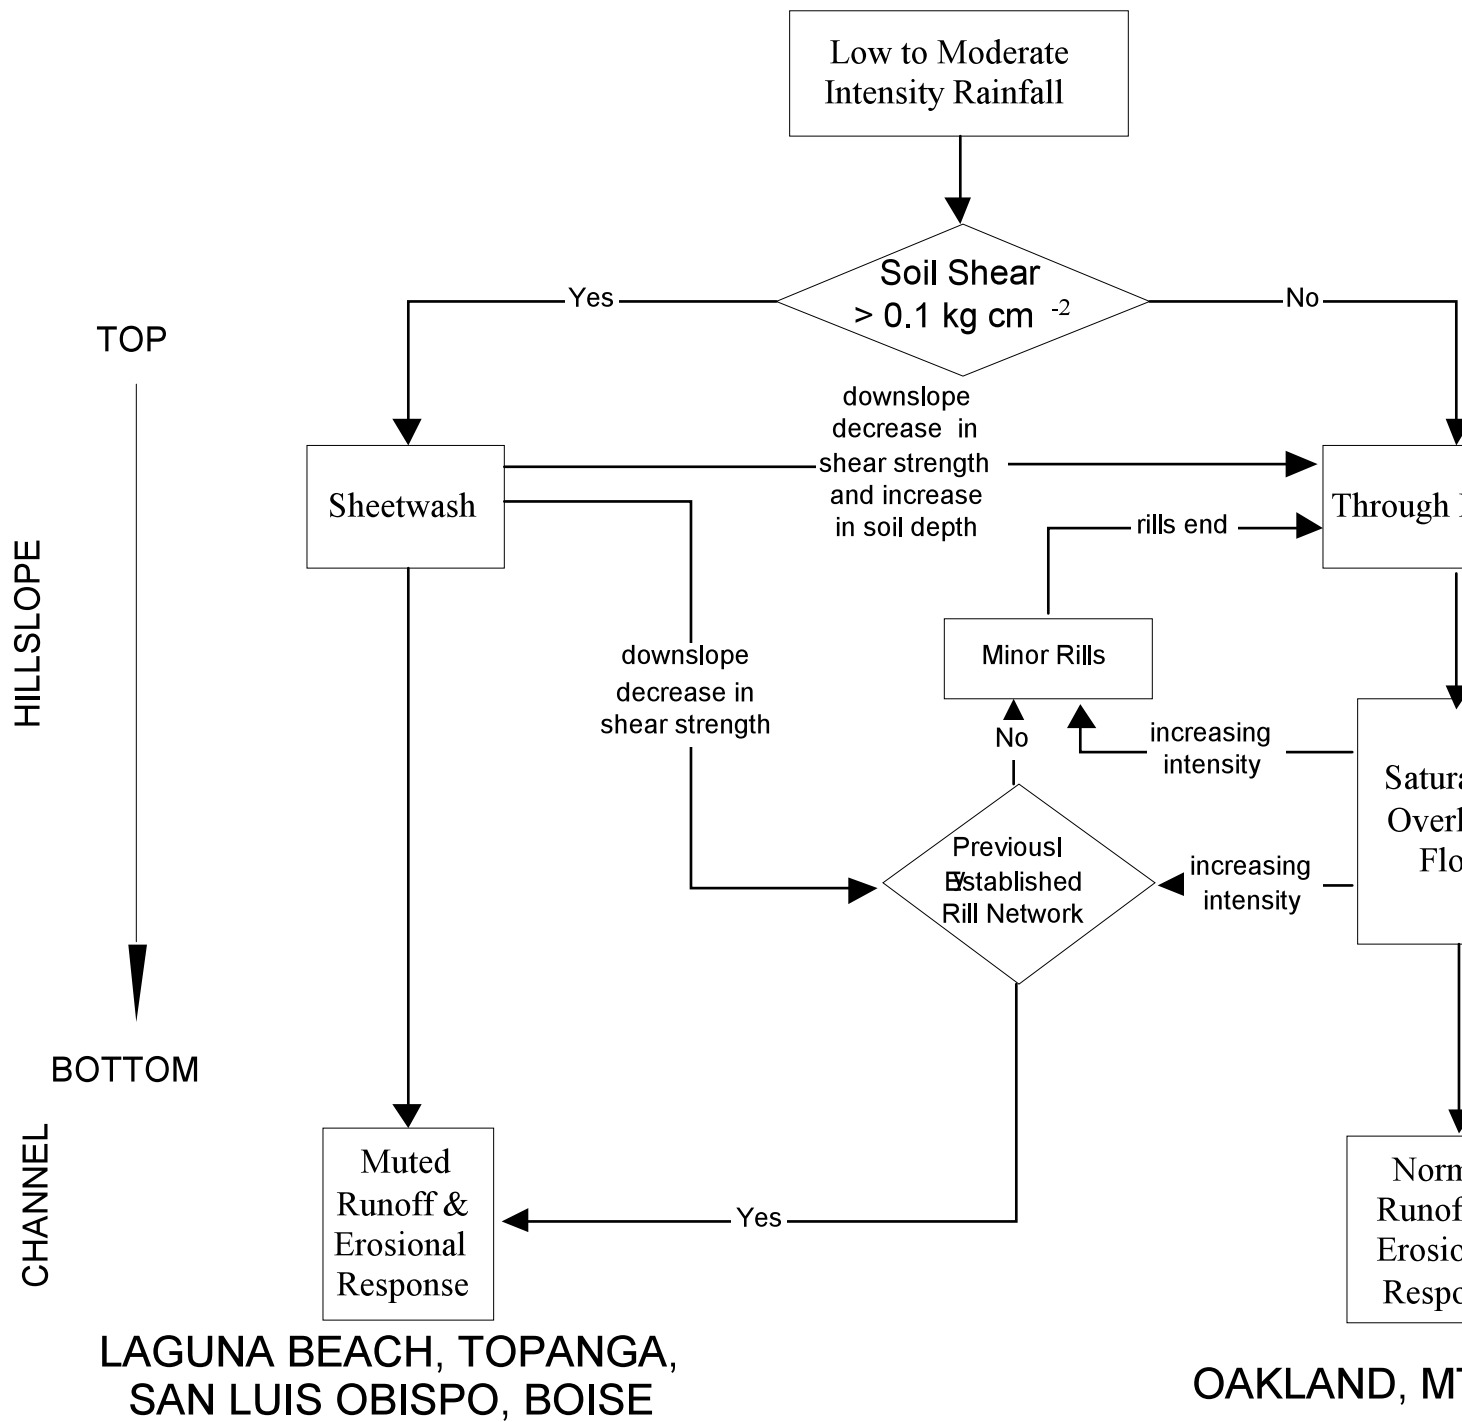
Figure 8b Hydrologic and Erosional Response for Moderate to Low Intensity

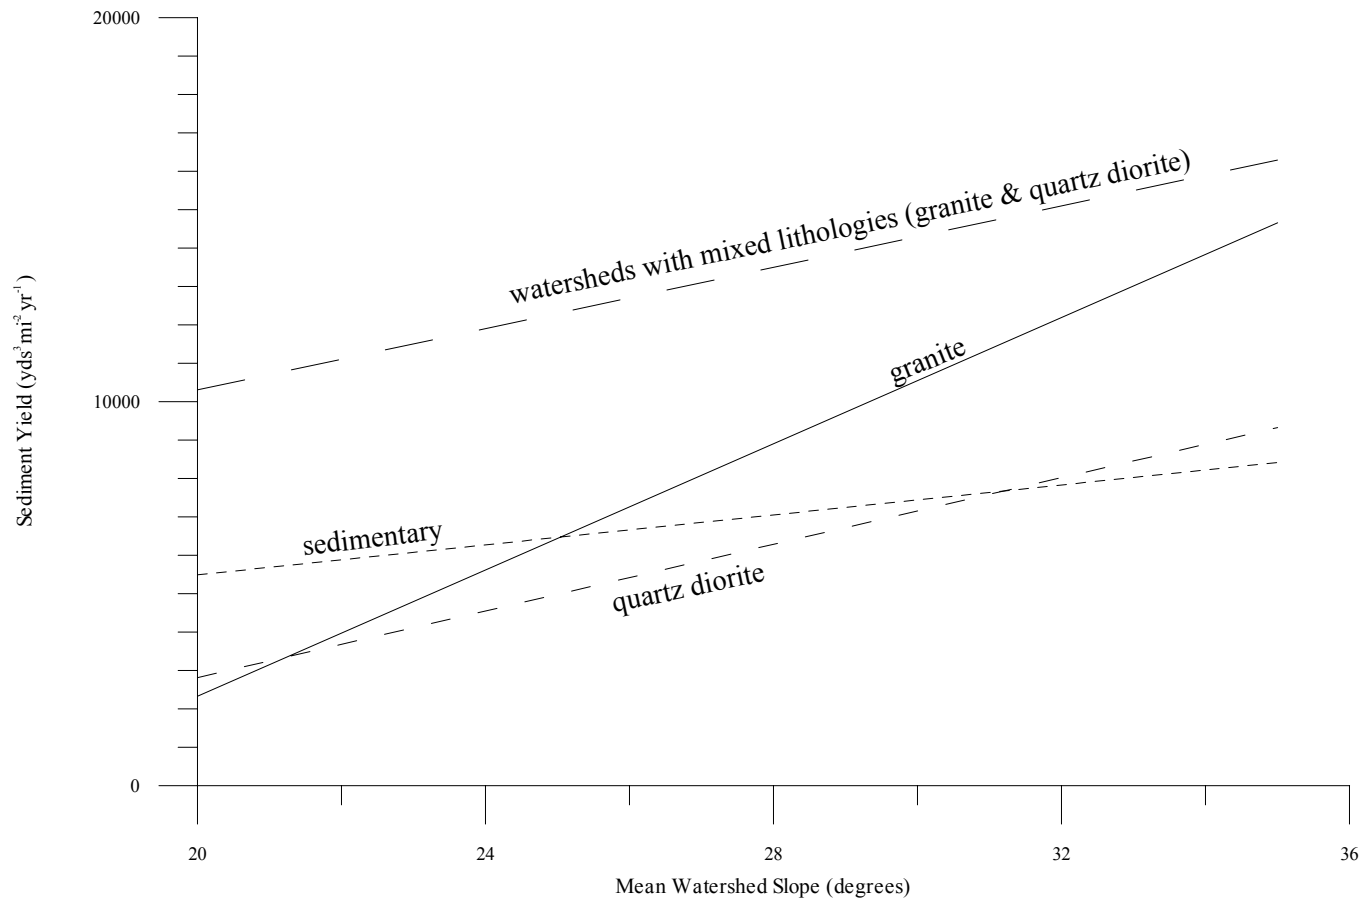
Figure 11 Erosional Sensitivity to Changes in Slope & Lithology  
 Sediment Yield for Los Angeles County Debris Basins with at least a 20 year record  
 (lines are best fit curves of the raw data)
